Seepage and Piping Dams

By
Ray E. Martin, PhD, PE

Washington Power Canal

April 21, 2002 Failure

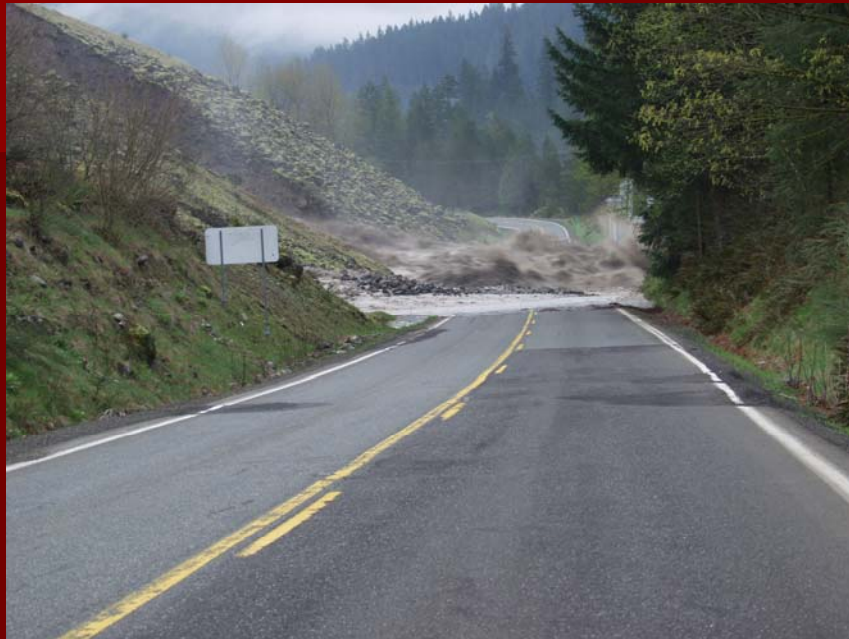
- Sinkholes developed in forebay at about 3:00 AM
- Blowout followed at toe of embankment
- Orifice expanded upstream causing breach of the embankment at about 6:30 AM
- Flooding destroyed downstream facilities
- Discharge contained in downstream reservoir

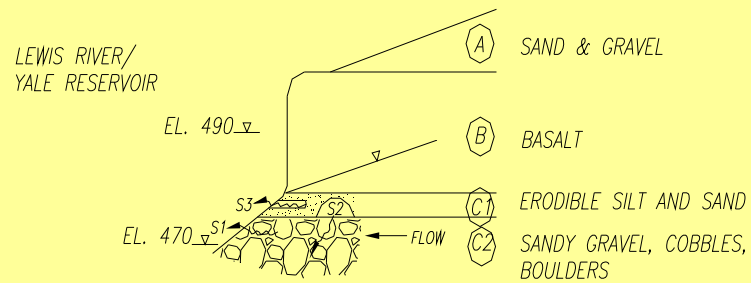
Beginning Internal Erosion Process

- High gradients caused internal erosion (segregation piping, continuing erosion and piping) of silts and sands from
 - Stratum C2 gravel, cobbles and boulders
 - Stratum C1 into Stratum C2, and
 - Within Stratum C1

S1=SEGREGATION PIPING
S2=CONTINUING EROSION
S3=PIPING

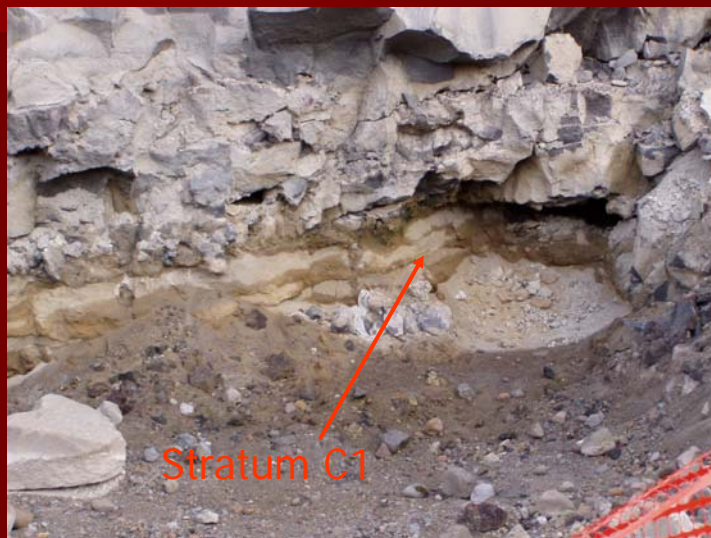
Stratum C1 Silt and Sand Under Basalt of Stratum B

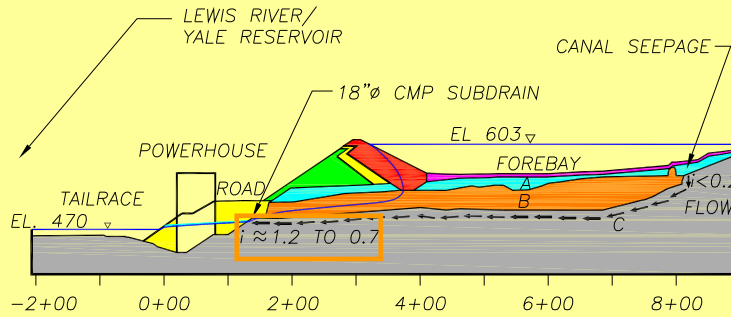
Post Construction – Powerhouse Seepage

- Gradients increased below basalt
 - At unfiltered 18 in dia. perforated subdrain pipe – 0.7 to 1.2
 - At unfiltered springs along tailrace/at lagoon – 0.3 to 0.8

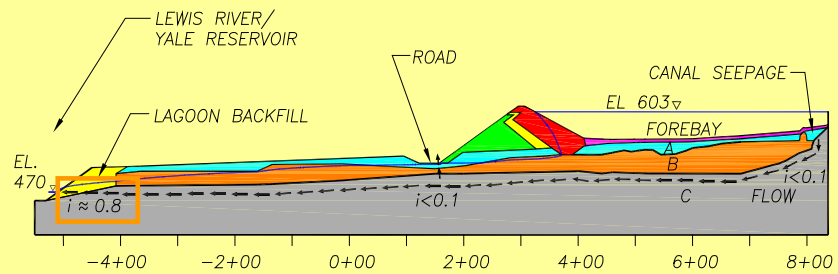
Post Construction – Lagoon Seepage

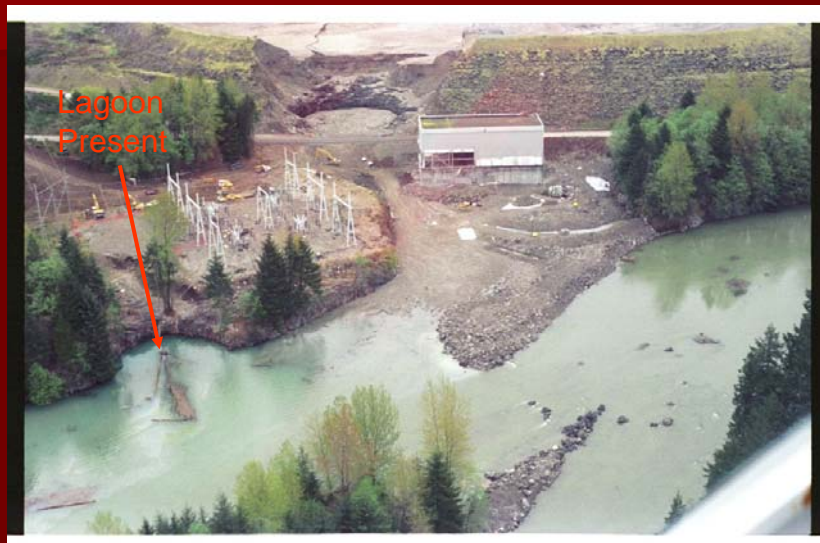
Pre- and Post Failure Lagoon

- Seepage gradients and forces increased below the basalt after the canal was filled with water
- Internal erosion can occur at small gradients under favorable conditions
- The presence of turbid (cloudy) water was indication that soil particles were being eroded from under the basalt
- Erosion of lagoon was indication of internal erosion

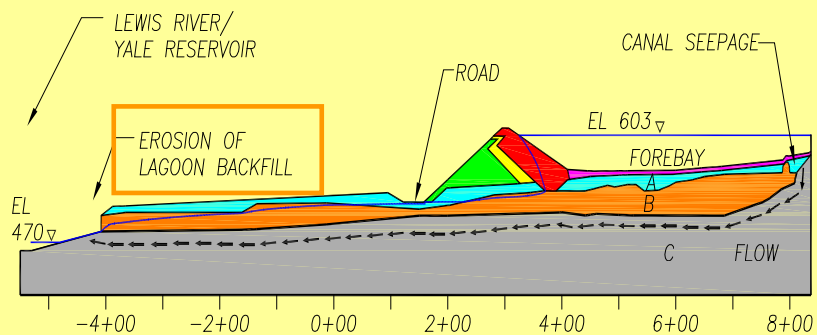
Initial Erosion of Lagoon

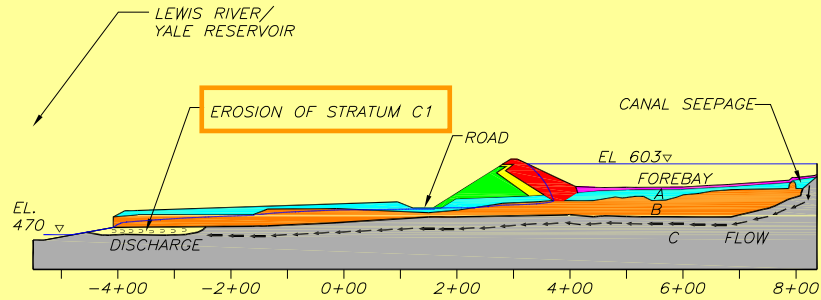
Erosion Tunnels Begin to Form Under Basalt

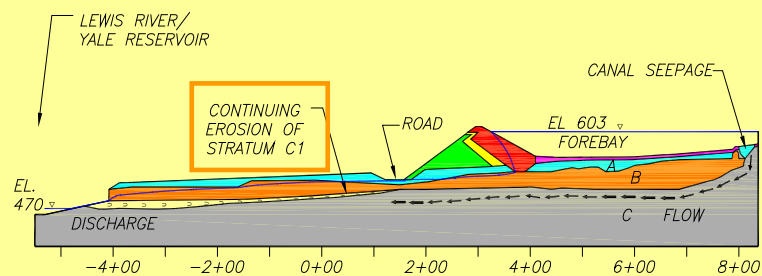
Continuing Erosion Under Basalt

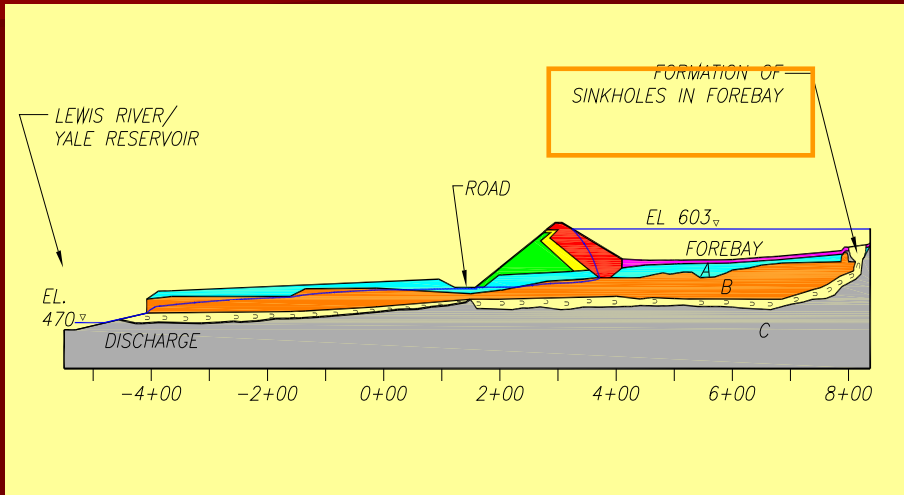
Sinkholes Form

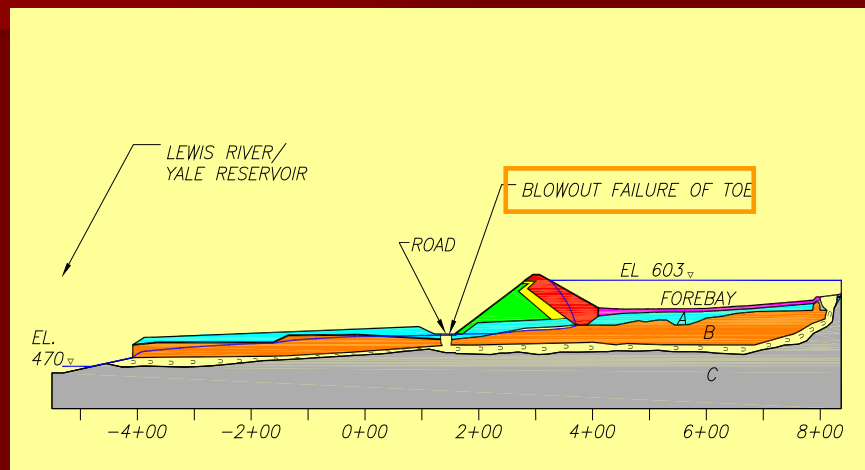
Ultimate Blowout

- Internal erosion progressed to canal bottom over 45 years of operation
- Sinkholes developed and water pressure under basalt rose to about 6100 psf
- Basalt and colluvium/alluvium thinnest at downstream toe – 8 and 10 ft, respectively
- Blowout occurred - maximum flow through expanding failure orifice about 3500 cfs
- Breach peak discharge - about 80,000 cfs
- Damage > \$100 million
