Seepage and Piping Dams

By
Ray E. Martin, PhD, PE

Washington Power Canal

April 21, 2002 Failure

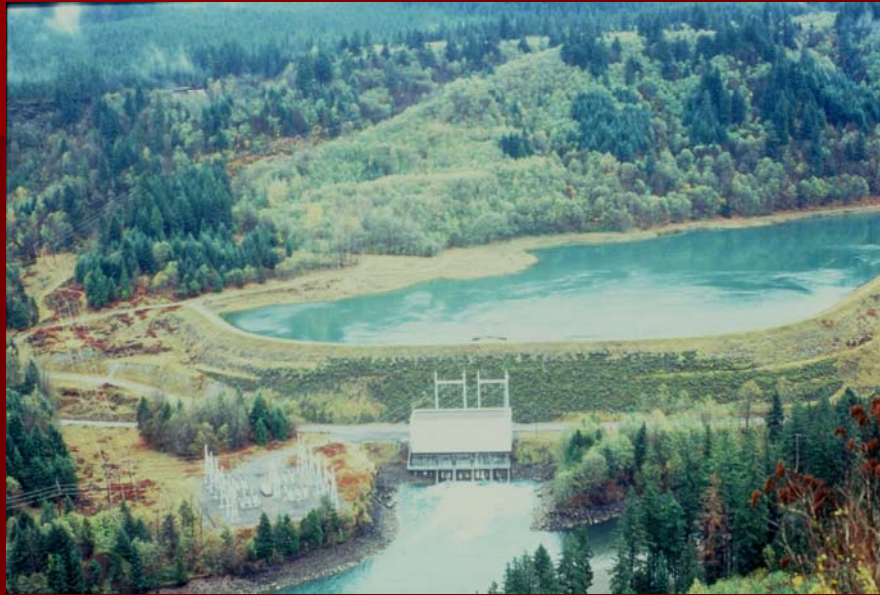
- Constructed - 1957 – 1958
- Length of water supply canal – 3 miles
- Impoundment - 2400 ac-ft
- Embankment height in forebay – 93 ft
- Maximum water depth – 53 ft
- Forebay operating pool level – El 603
- Operating tail race levels – El 470 to 490

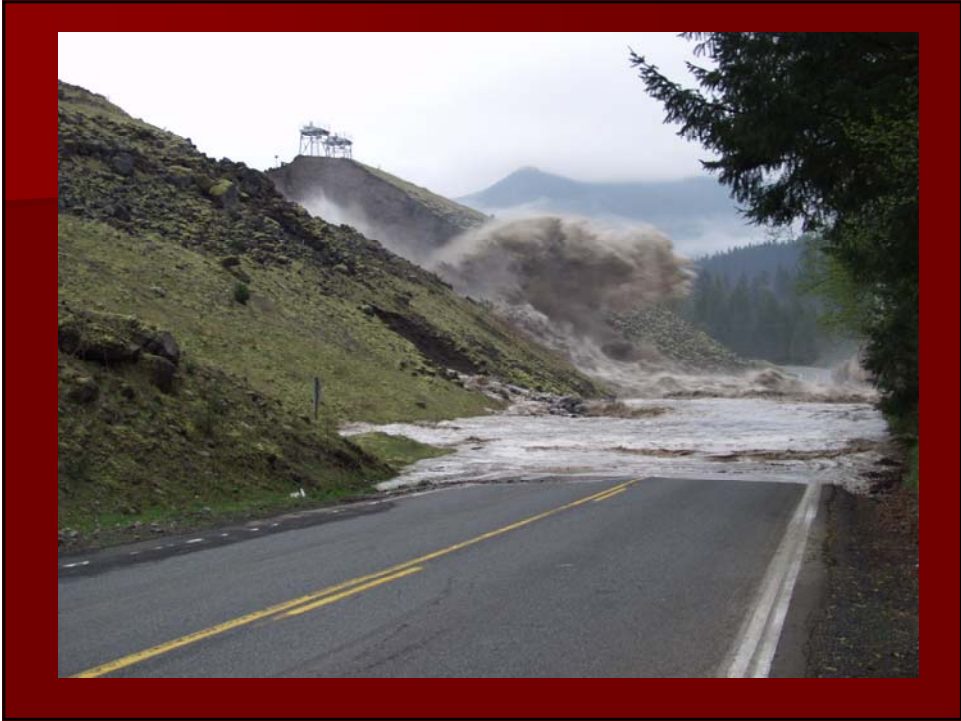
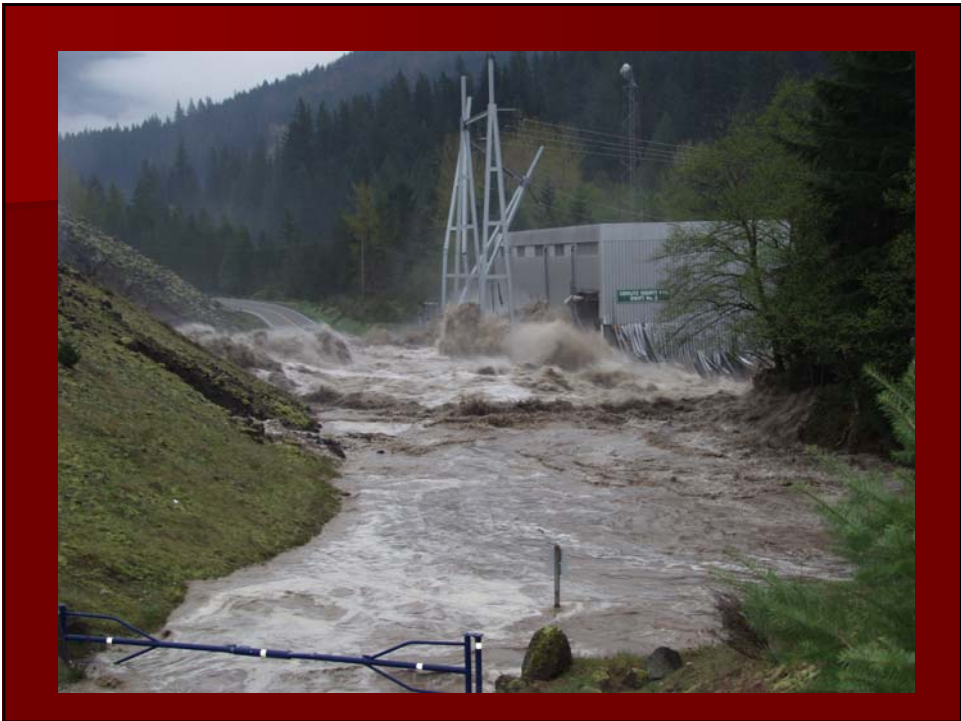
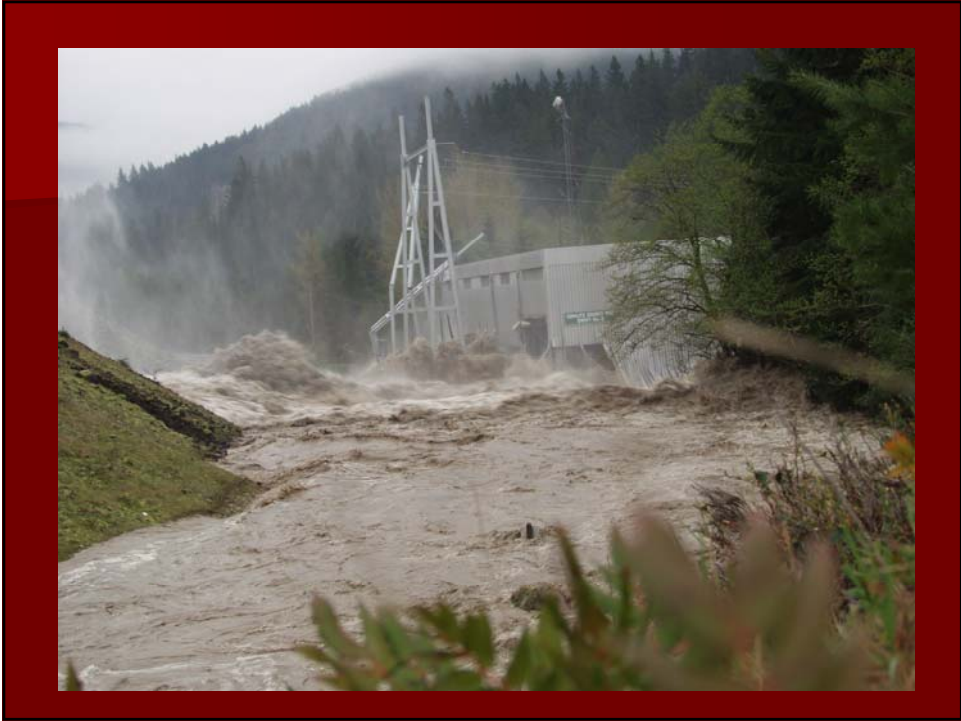
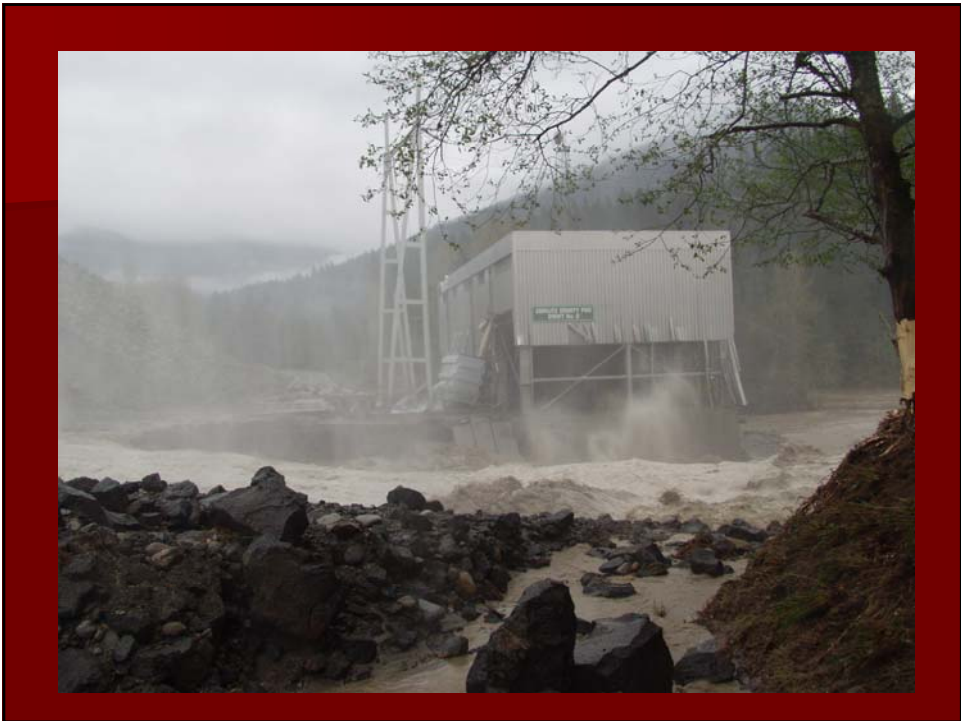
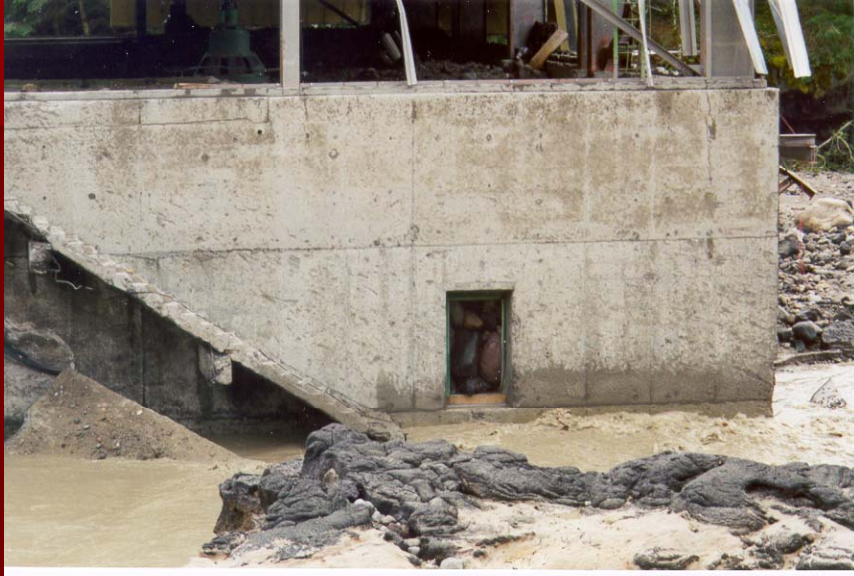
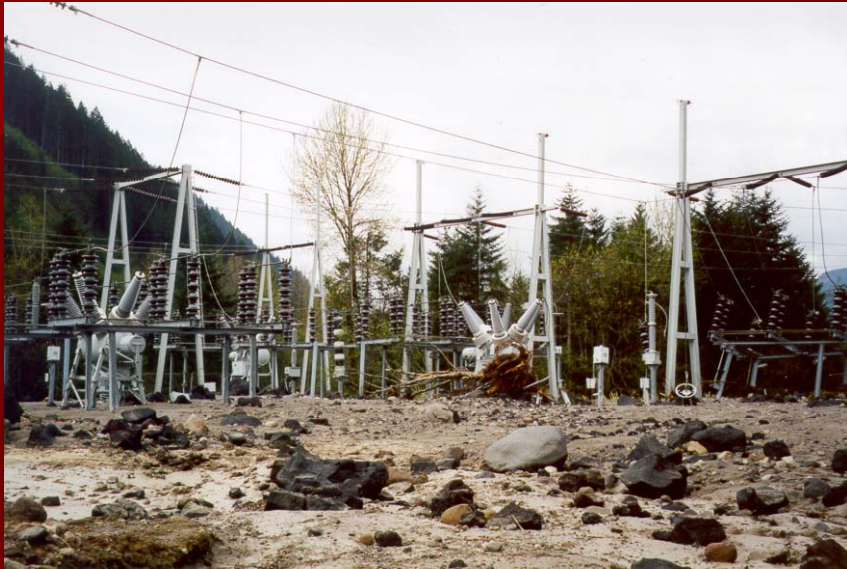
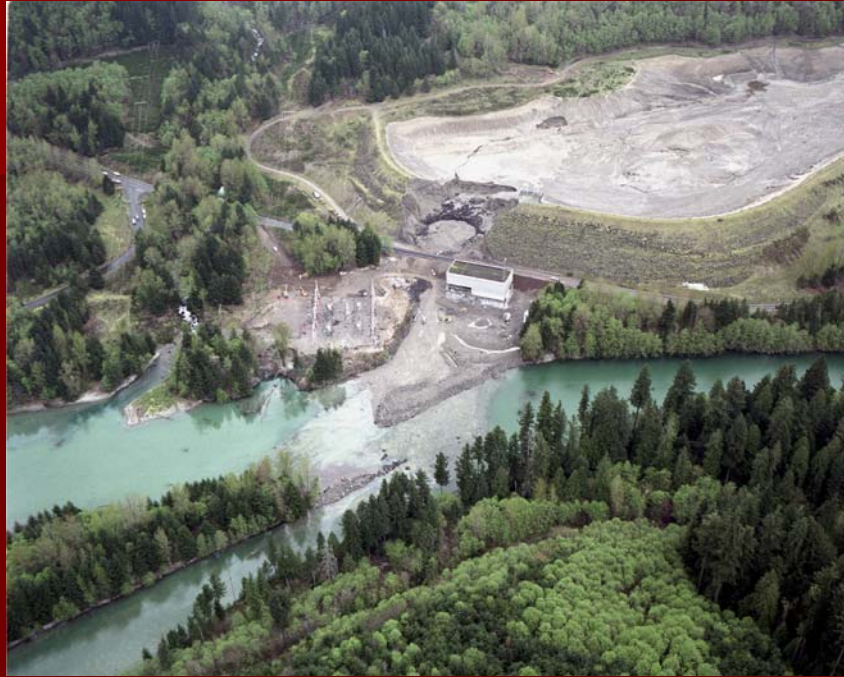
- Sinkholes developed in forebay at about 3:00 AM
- Blowout followed at toe of embankment
- Orifice expanded upstream causing breach of the embankment at about 6:30 AM
- Flooding destroyed downstream facilities
- Discharge contained in downstream reservoir

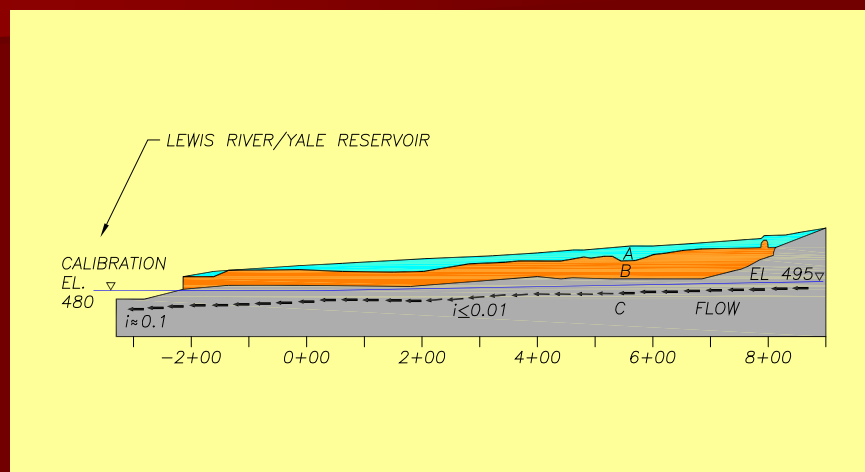
Preconstruction Groundwater Conditions

- Groundwater surface generally at about interface of basalt and underlying alluvium [test borings - 1956]
- Due to low preconstruction gradient, ($i = < 0.01$ to 0.1) erosion likely did not occur below basalt before canal was constructed

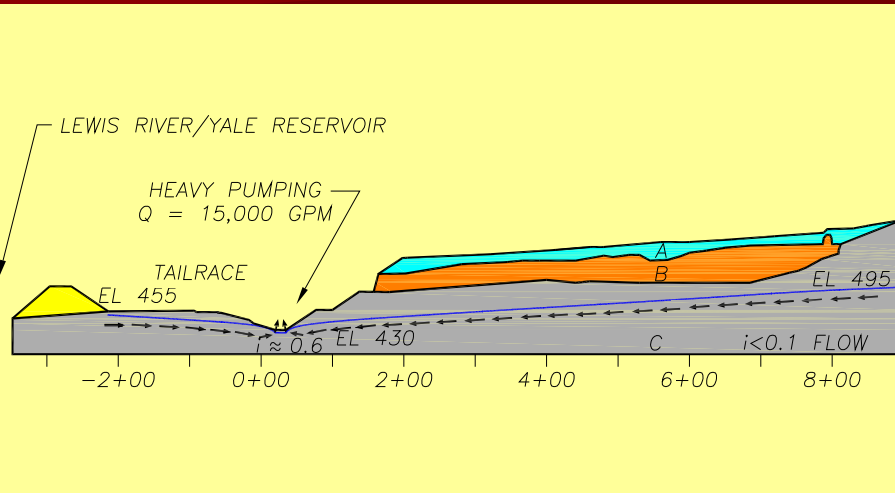
Construction Groundwater Conditions

- Groundwater lowered about 60 ft
- Pumping rates – 7,000 to 15,000 gpm (4 mo)
- Estimated 4,000 ac-ft of groundwater pumped
- Unfiltered discharge
- Pumping imposed gradient – 0.6
- Heavy pumping caused internal erosion of silts and sands from Stratum C gravel, cobbles and boulders below Basalt

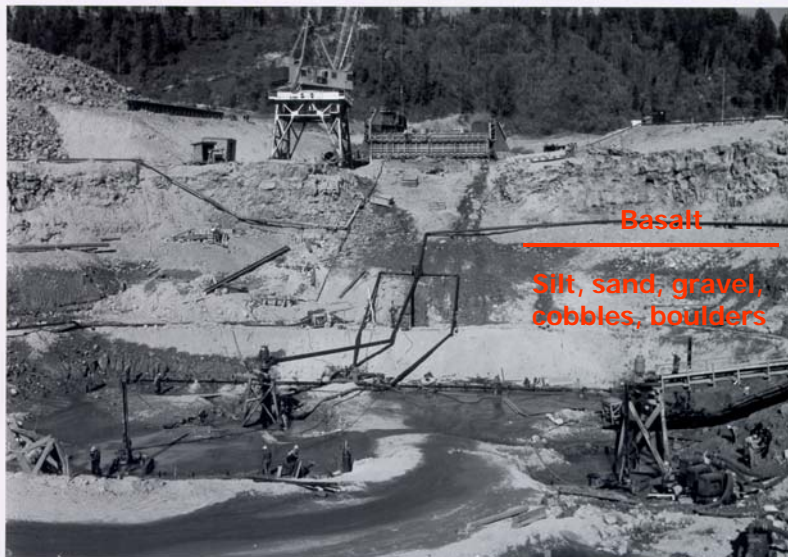
2145-111
SEPTEMBER 23, 1957

SWIFT HYDROELECTRIC PROJECT
EXCAVATION FOR POWERHOUSE NO. 3, LOOKING UPSTREAM.

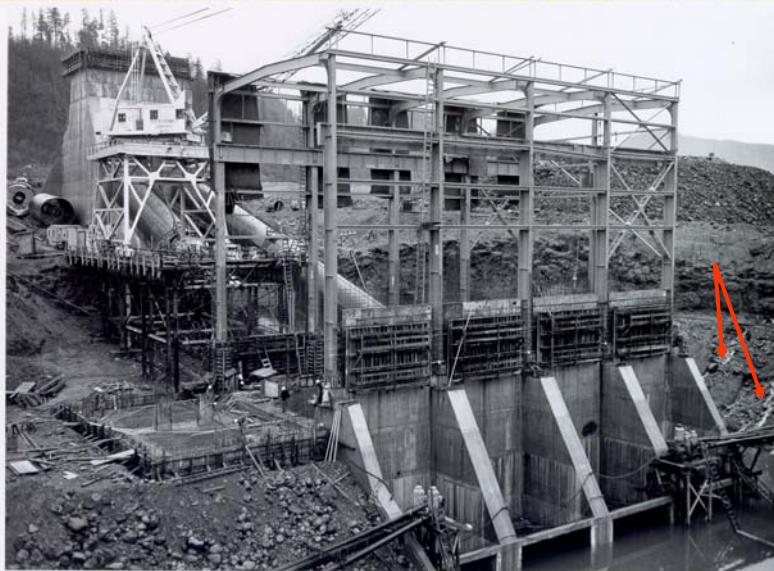
2145-158
FEBRUARY 18, 1958

- Subdrain installed upstream of powerhouse due to heavy flow coming from below basalt
- Unfiltered 18 in dia. perforated CMP placed just below interface of basalt and underlying alluvium

SWIFT HYDROELECTRIC PROJECT
POWERHOUSE NO. 2, LOOKING UPSTREAM. POWER INTAKE STRUCTURE AND STEEL PENSTOCKS
IN LEFT BACKGROUND. NOTE INITIAL CONSTRUCTION OF SERVICE BAY IN LEFT FOREGROUND.

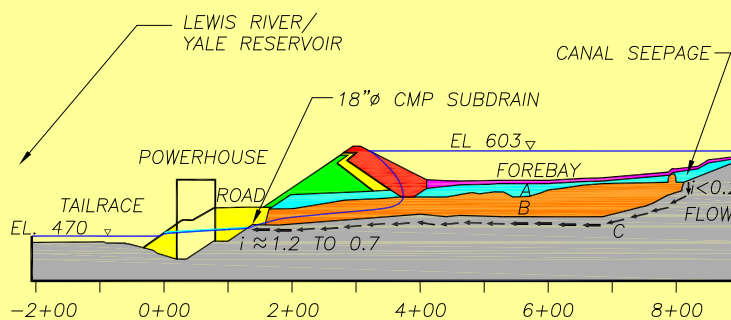
Construction of Embankment

- Cutoff trench 300 ft - both sides of intake structure through alluvium/colluvium
- Grout curtain partially penetrated basalt
 - Typically - 20 ft deep
 - Five holes penetrated basalt, 40 to 45 ft deep
 - No seepage barrier was formed below basalt
- Forebay blanket – silty sand with gravel (SM)
- Zoned Embankment
